Sustainable façade rehabilitation protocol for residential buildings in historic districts: The Spanish Quarter of Naples, Italy

Pasqualina Gentile¹, Mercedes Galiana^{2*}

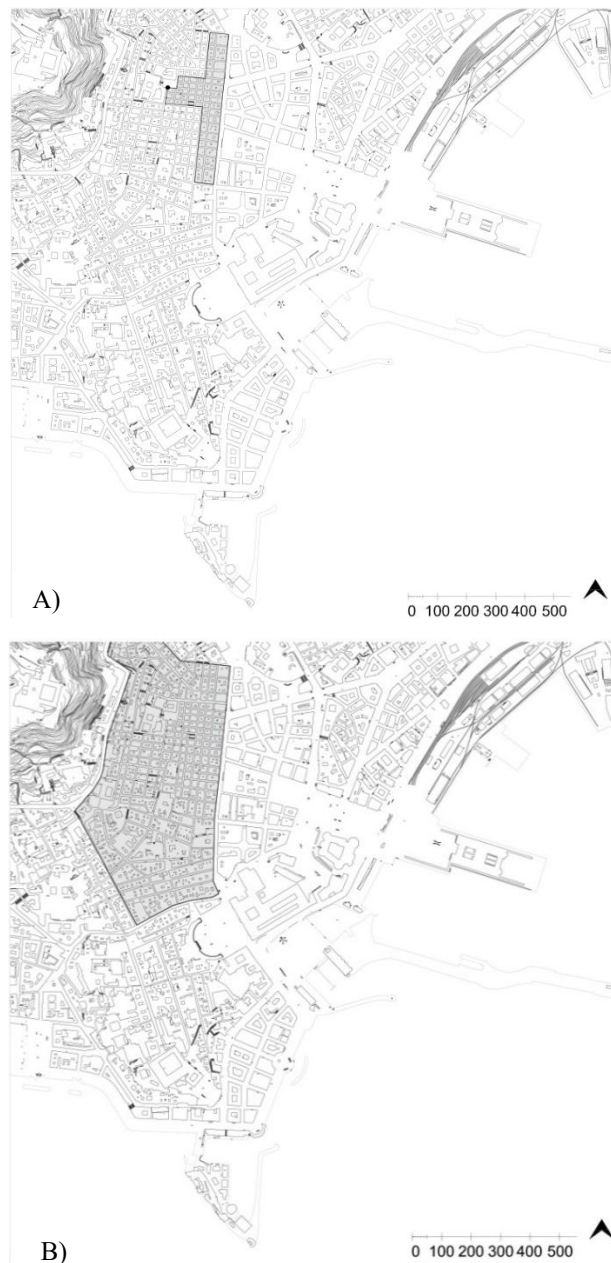
Figure 1. A) Spanish Quarter of Naples; B) Perimeter of the study area

The Spanish Quarter, located in the heart of the historic center of Naples, was founded in the mid-16th century as a settlement for the Spanish militia under Don Pedro Álvarez de Toledo y Zúñiga (Figure 1, A). The viceroy, who arrived in the city in 1532 and ruled for 20 years, promoted the transformation of Naples, providing it with a proper urban planning framework [15].

The Quarter, which covers an area of nearly 80 hectares, was originally designed with an orthogonal layout, featuring perpendicular streets that create predominantly square city blocks, each about 20 meters per side (Figure 1, B). These blocks were occupied by two-story buildings, separated by courtyards and gardens, with a well-balanced street section that ensured adequate sunlight and ventilation.

The first step to be carried out is the demarcation and identification of the buildings to be studied, in this case, those of the Spanish Quarter of Naples (Figure 1).

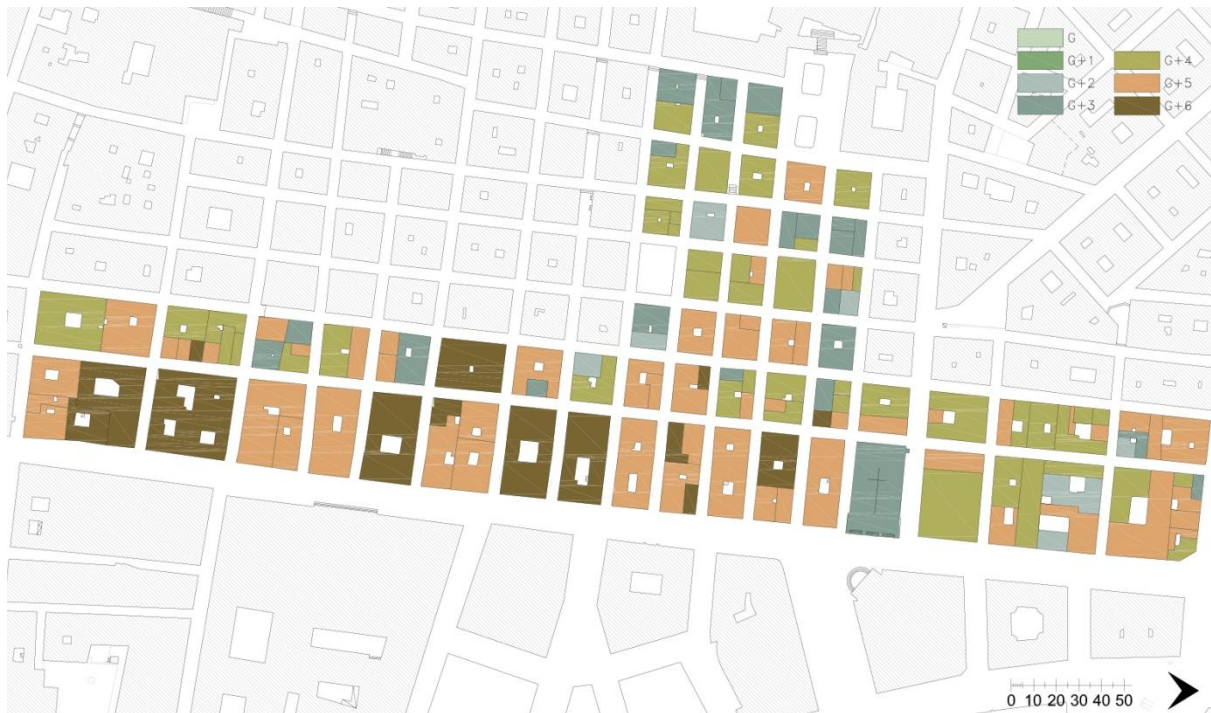
Figure 2. Height of the buildings in the study area

However, almost from the outset, the original buildings began to undergo chaotic and uncontrolled modifications and extensions. New additions occupied the former courtyards and gardens, raising the height of the buildings to five or six stories (Figure 2). This vast new volume altered the balance of the street sections as they originally existed, leading to congestion and physical and environmental degradation of the Quarter (Figure 3).

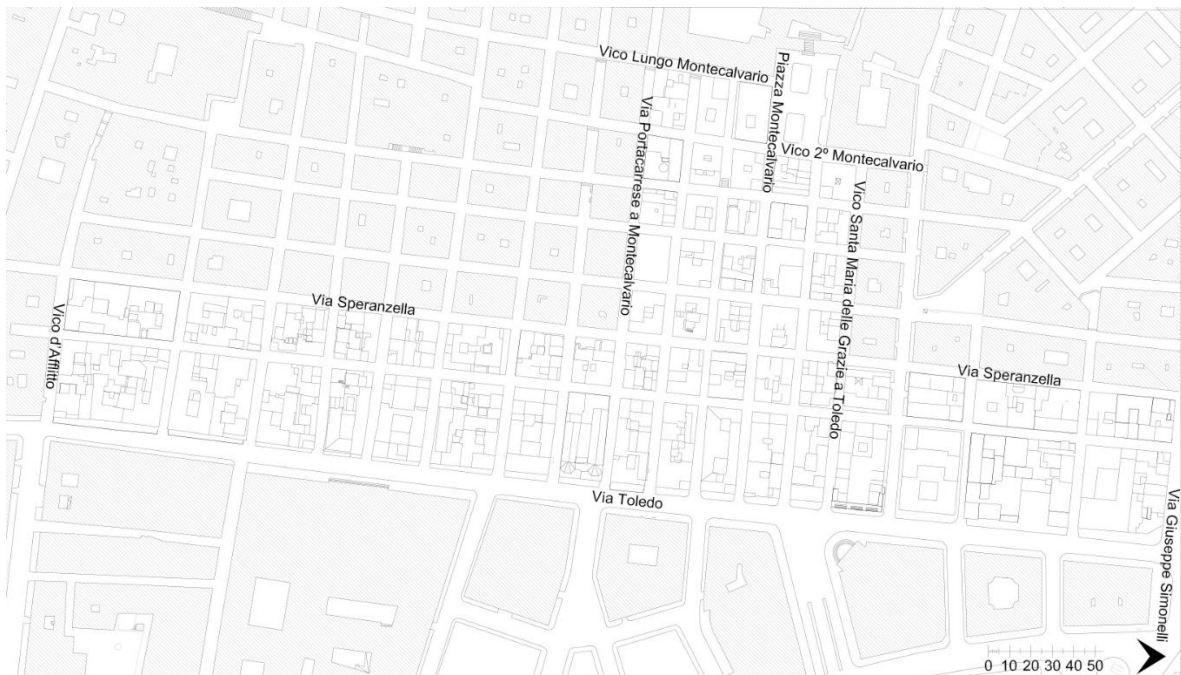
Figure 5. Perimeter of the study area of the Spanish Quarter of Naples

As mentioned, the Quarter has a grid layout formed by square city blocks, approximately 20 meters per side, except for those adjacent to Via Toledo, which are twice the size in the direction perpendicular to this perimeter street [19]. The area to be assessed, with a T-shaped plan, is located in the heart of the Quarter, adjacent to its right flank, and is delimited as follows: to the east by Via Toledo; to the west by Via Speranzella, Vico Secondo Montecalvario, and Vico Lungo Montecalvario; to the north by Via Giuseppe Simonelli, Vico Santa Maria delle Grazie a Toledo, and Piazza Montecalvario; and to the south by Via Portacarrese a Montecalvario and Vico d'Afflitto. It includes 16 perpendicular streets and 6 parallel streets to Via Toledo (Figure 5).

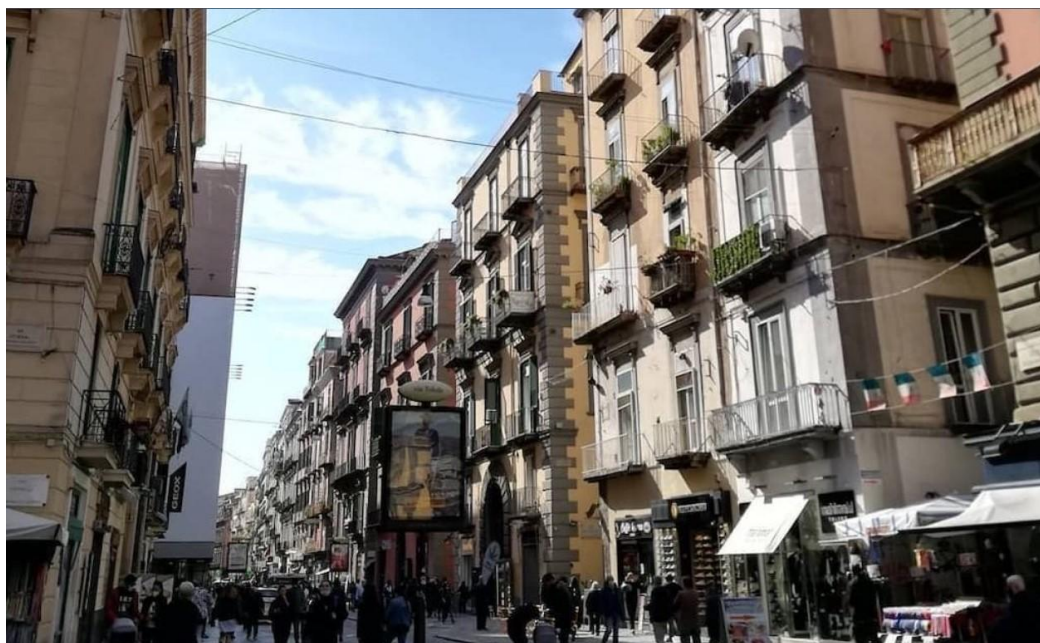
Figure 6. Via Toledo, Spanish Quarter of Naples

It includes a group of 63 buildings, some of which occupy entire city blocks. Although they feature varied compositional schemes and materials, they share characteristics that define and reflect their common historical and architectural past (Figure 6).

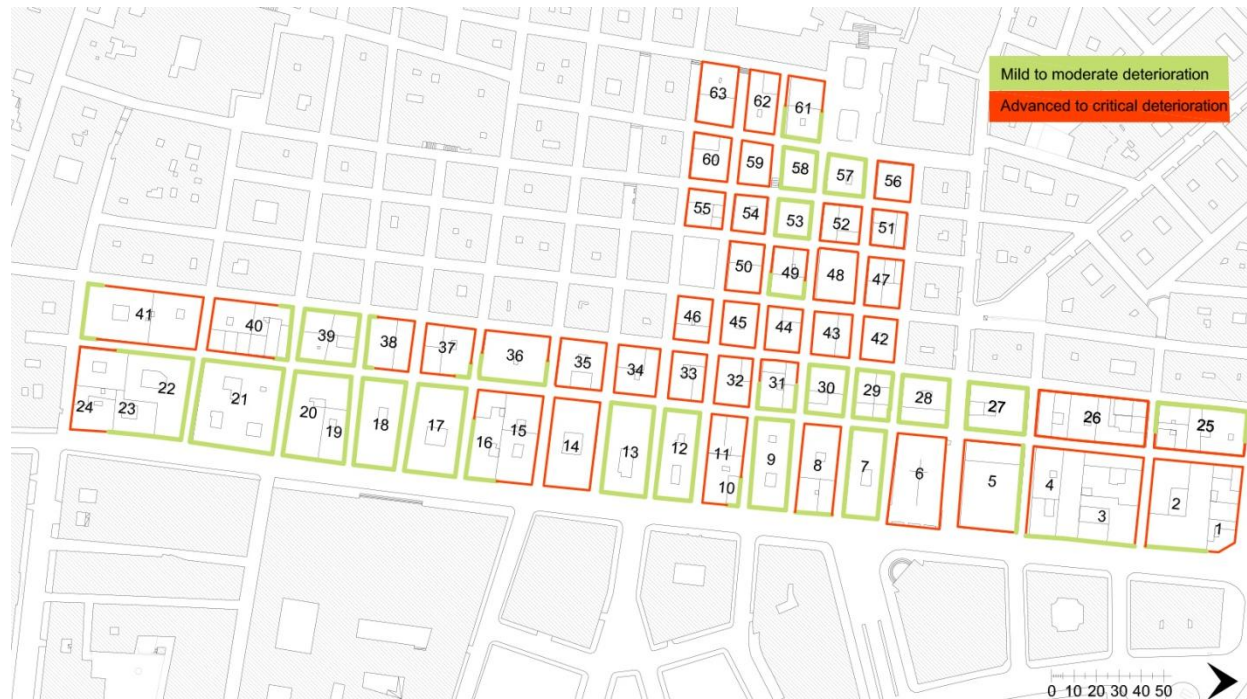
Figure 8. Level of façade deterioration in Naples' Spanish Quarter

First, the existing level of façade deterioration in the neighborhood is mapped onto a district plan for the 56 built blocks comprising the 63 buildings examined in this study. As shown in Figure 8, only 16 blocks— less than 30% of the total—have undergone rehabilitation works in recent years, in many cases more than a decade ago, and they generally exhibit mild to moderate deterioration. Of the remaining 70%, 15 blocks display an uneven conservation condition, having been subject to partial rehabilitation interventions affecting only the façades of some of the buildings within each block, while the rest show an advanced to critical level of deterioration.

The highest number of recently rehabilitated vertical enclosures is concentrated along Via Toledo, while the level of deterioration of the vertical building envelopes increases as one moves further into the neighborhood in a westward direction.

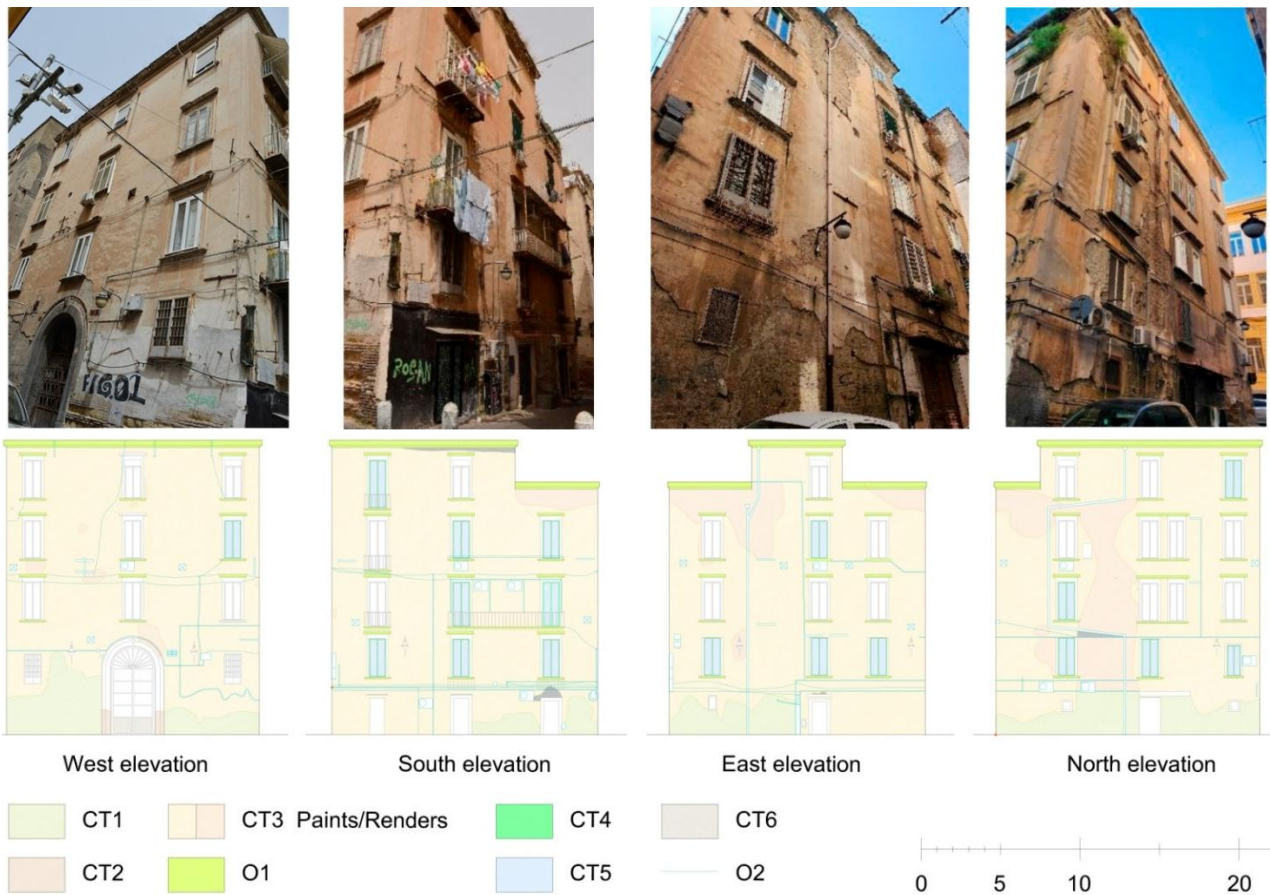
Figure 9. Façade damage map of Building No. 56

These coded damages were represented in façade elevation damage maps for each of the 63 buildings (Figure 9).

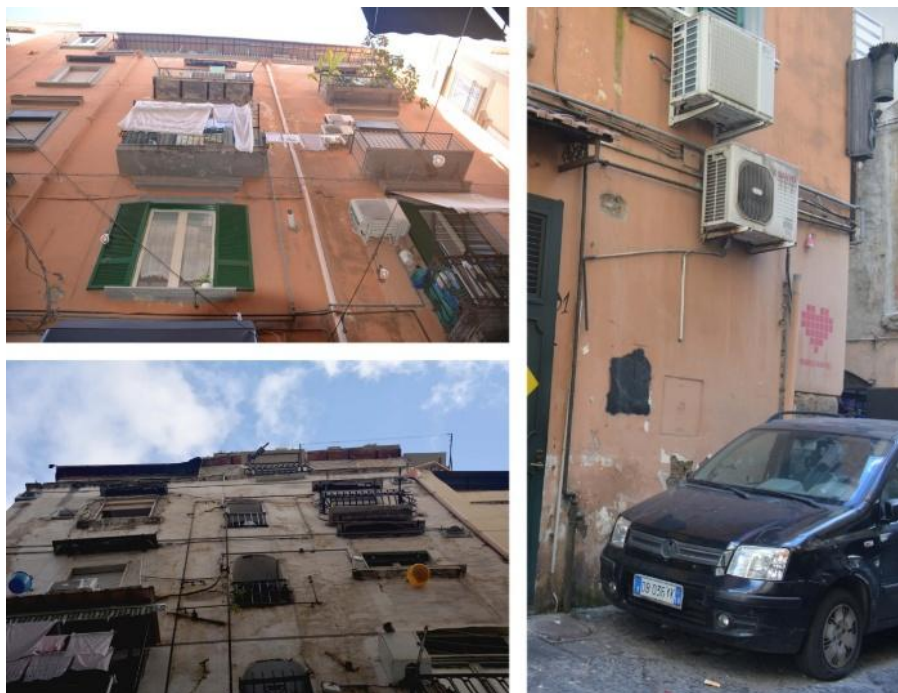
Figure 10. Poorly integrated installations within the compositional design of the façade

These mainly include air-conditioning units, which are often installed haphazardly—either on balconies or suspended from anchors fixed to the blind sections of façades. All such devices should be removed and relocated to designated areas on the rooftops. Wiring should be routed through interior courtyards in an orderly manner and under the agreement of the homeowners' associations.

It is necessary to rectify the layouts of these installations by relocating the former preferably to the sides of the building, thereby minimizing their visual impact. In the case of electrical wiring, conduits should be properly anchored to the façade at the junction between the plinth and the first floor, housing all cables and harmonizing with the aesthetic of the façade through the selected color palette.

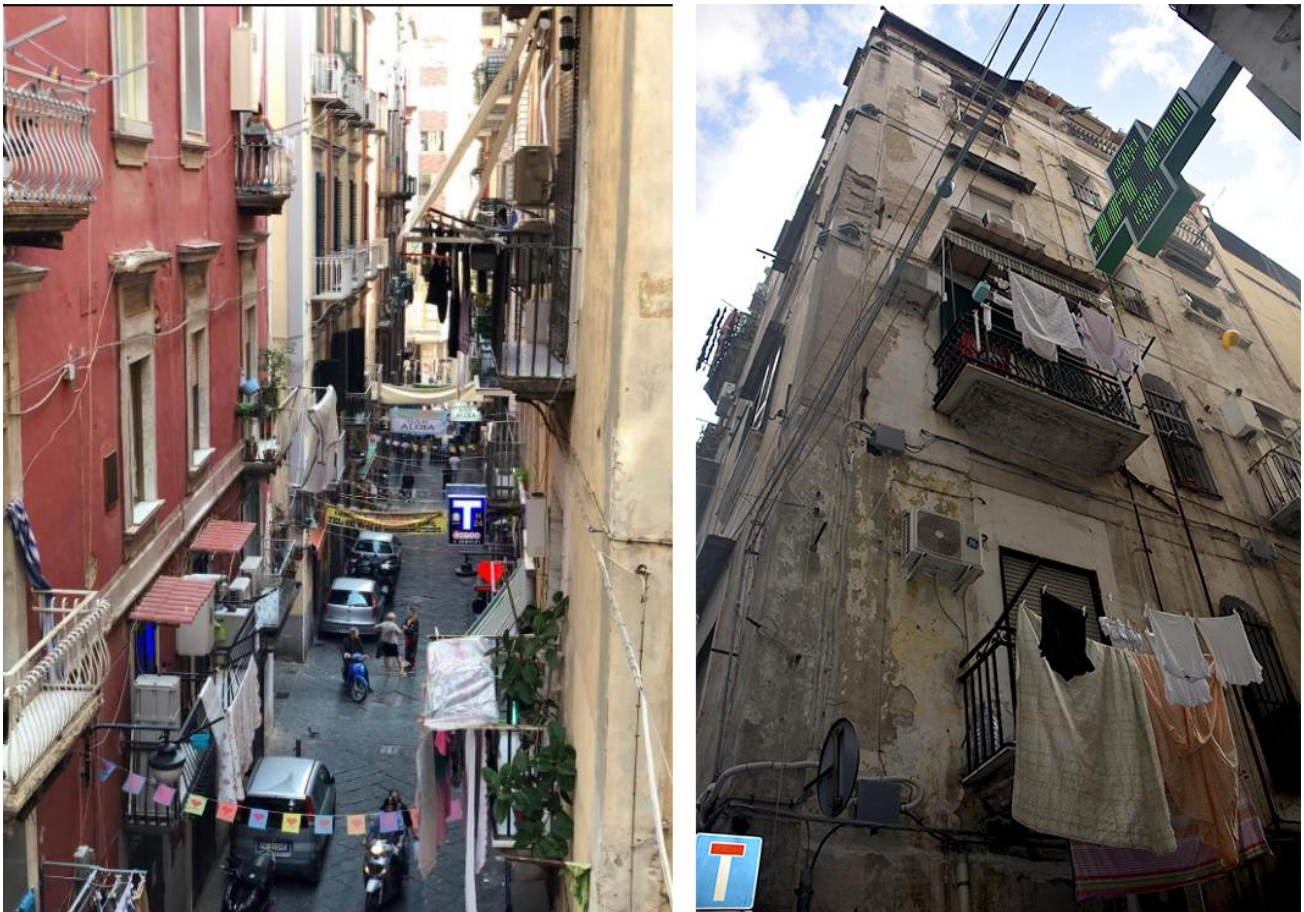
Figure 11. Overhanging clotheslines distort the compositional image of the façades and enhance the perception of narrowness in the streetscape

Finally, the municipality or homeowners' associations should prohibit the use of exterior balcony clotheslines to prevent the visually disruptive effect of laundry hanging over the public streets in the narrow lanes typical of historic neighborhoods (Figure 11). At the same time, communal clothes-drying areas should be established on the rooftops.
