## The role of cultural value in sustainable heritage reuse - the intervention on Teatro Thalía in Lisbon

Domingo Galán-Caro<sup>1\*</sup>, Mar Loren-Méndez<sup>2</sup>, Marta García-Casasola<sup>3</sup>

<sup>1,2,3</sup> Department of History, Theory and Architectural Composition, University of Seville, Spain

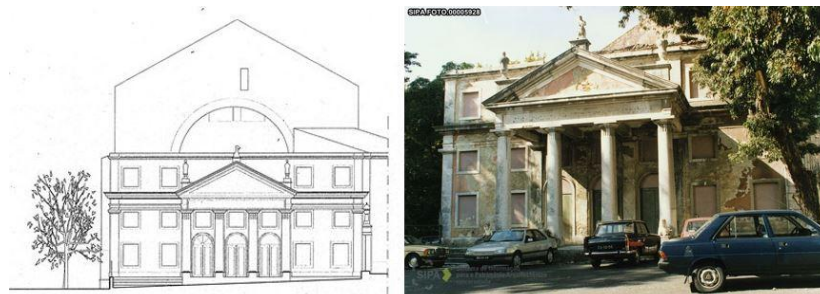
Figure 4. Elevation and image of the theatre's south façade prior to the intervention. DGEMN, 1991

Although nothing remained of the theatre's luxurious dressing rooms and ballrooms, what was left encapsulate the identity of what it once was, and what was no longer there was perceived in its absence [7] [9]. The original construction had two floors in its entrance section, with an additional height at the cornice. Following neoclassical lines, access to the building was via a podium, which led to a neoclassical façade with seven openings (Figure 4). On this 20-meter-long façade, four Doric columns support a triangular pediment with a flat tympanum, on which stands a statue of Erato, muse of choral and love poetry in Greek mythology. The acroteria feature two urns, and in its extensions, on plinths raised from the peristyle, four stone sculptures representing sphinxes reclining. According to reviews, the theatre was of a modest, almost domestic size (around 560 spectators), but had a box seat of considerable size, which highlighted the flexibility and capacity of the stage machinery (Figure 5) [8] [7].

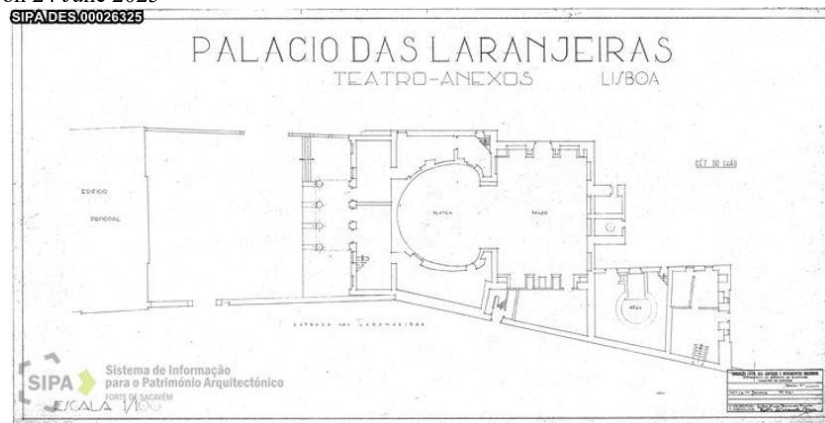
Figure 5. Ground floor of Teatro Thália and its annexes prior to the intervention. DGEMN, 1991

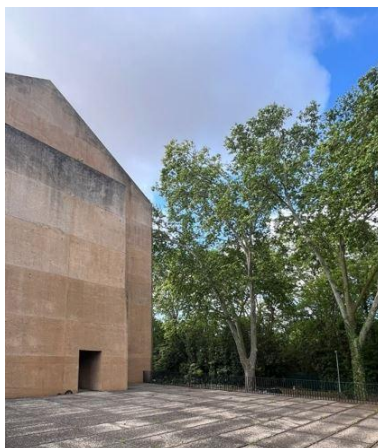
Figure 6. View of the elevated plaza from the back of the original volume, showing the building and its relationship with the surrounding natural environment.

The action strategy proposed in the project is based on protecting the existing structures by maintaining the original performance spaces and adapting them to new uses: conferences, meetings, receptions, small concerts, and various types of stage performances. To this end, the ruins are being cleaned up, with the three original structures (atrium, stalls, stage) being preserved and the annexes that housed the more secondary and service elements being demolished, as it is understood by the project team to be elements that seriously compromise the interpretation of the building's main attributes, such as its verticality and volumetric composition. That is why, once the main original elements have been enhanced, a new volume is proposed to meet the technical needs of the new functions that the building will host (conciierge, toilet areas, storage rooms, technical spaces, cafeteria and support areas), as well as establishing new relationships with the landscape and the public spaces, always seeking the majesty of the monument from the outside. This idea of lightness and transparency in the new construction reinforces the strategy of enhancing the natural environment surrounding the building. For this reason, it forms a plaza that is elevated above the level of the garden, thus allowing for greater enjoyment of the vegetation and incorporating it into the intervention (Figure 6).

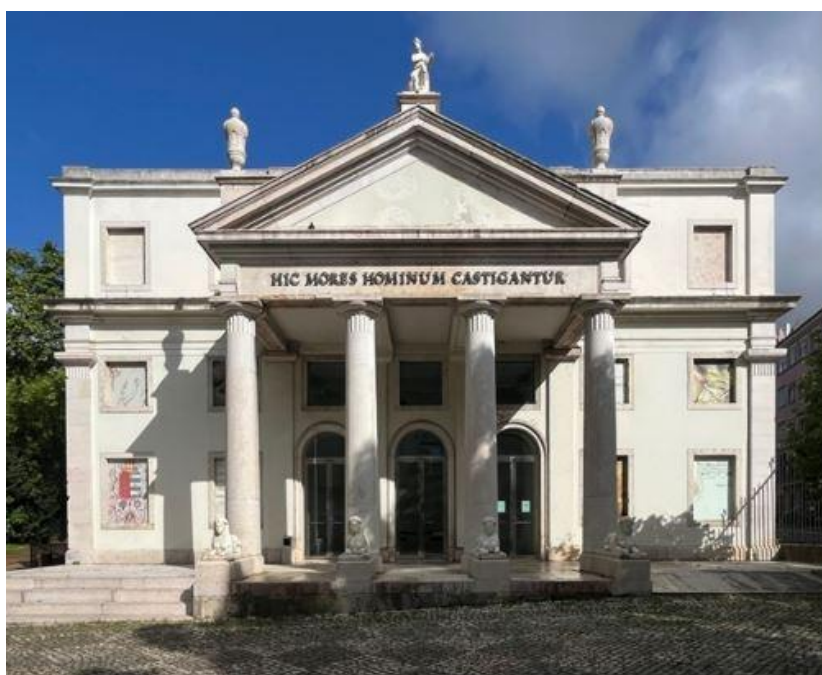
Figure 7. image of the south façade after restoration

In the new volume, because the vertical walls are made of glass or the original recovered structure, false ceilings made of sheet metal are installed, allowing the necessary installations to be routed to the most representative spaces of the building. In keeping with the intention to preserve the identity and character of the monument, the existing masonry and stucco of the atrium or foyer have been fully restored. The terracotta tone of the walls has therefore been maintained in the flooring, looking its extension in stone in the entrance peristyle, where the interior space is extended. Continuing with the conservation of the original building, another type of intervention on the ruin is worth noting, namely that carried out on the building's entrance. Here, contemporary techniques are used to offer solutions that seek to enhance the original style. For example, the fluted frieze at the entrance has been reconstructed, but with the introduction of innovative materials in this case, as it has been built using polyurethane foam mouldings. Stonework has also been carried out, in this case using lioz stone, thus also ensuring harmony with the environment. It was also necessary to restore some elements such as the peristyle and the marble sphinxes located at the entrance. As part of this work, the inscription “Hic Mores Hominum Castigantur”, meaning “Here human behaviour is punished”, was also replaced on the façade [13] (Figure 7).

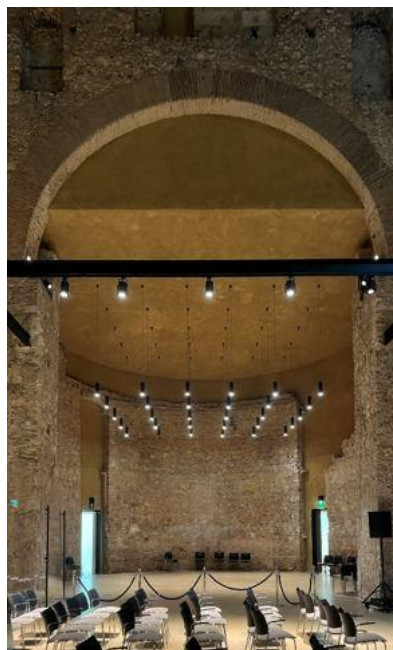
Figure 9. Image of the interior of the restored and consolidated existing building, showing the compatibility of the materials

With the idea of preserving the ruin through minimal intervention, earth-toned pigmented reinforced concrete with a texture similar to mortar was chosen to achieve an appearance very similar to that of the existing masonry (Figure 9). As this concrete is also used as a cladding for the façades, a technique known as ‘deactivated concrete’ is used, which achieves a rough and continuous final texture, where the joints are concealed. In this way, the entire intervention takes on a monolithic character. In addition, the same material is used for the new structures that have been added, which serve as support for the light metal structure that unifies the entire project, consisting of slender pillars made of steel profiles.

As the interior was left virtually untouched, the necessary insulation was placed on the soffit of this new structure. Acoustic insulation made from paper pulp was sprayed onto the original walls [7].
