# Ecological and environmental effects of urban transformation: An example in Turkey

Sur district in Diyarbakir city like all historical places in Mesopotamia is a city that has rich historical buildings. The urban transformation has become a necessity as a result of the historical process, unplanned construction, change of tools and equipment in transportation, environmental and ecological problems, and social activities. For this reason, urban transformation applications have been started in Sur. As a result of the transformation; the formerly irregular constructions and environment have become regular. Accordingly, many environmental problems have been reduced. In addition to this, due to the exchange in the originality of historical architecture, some negatives have been experienced too.

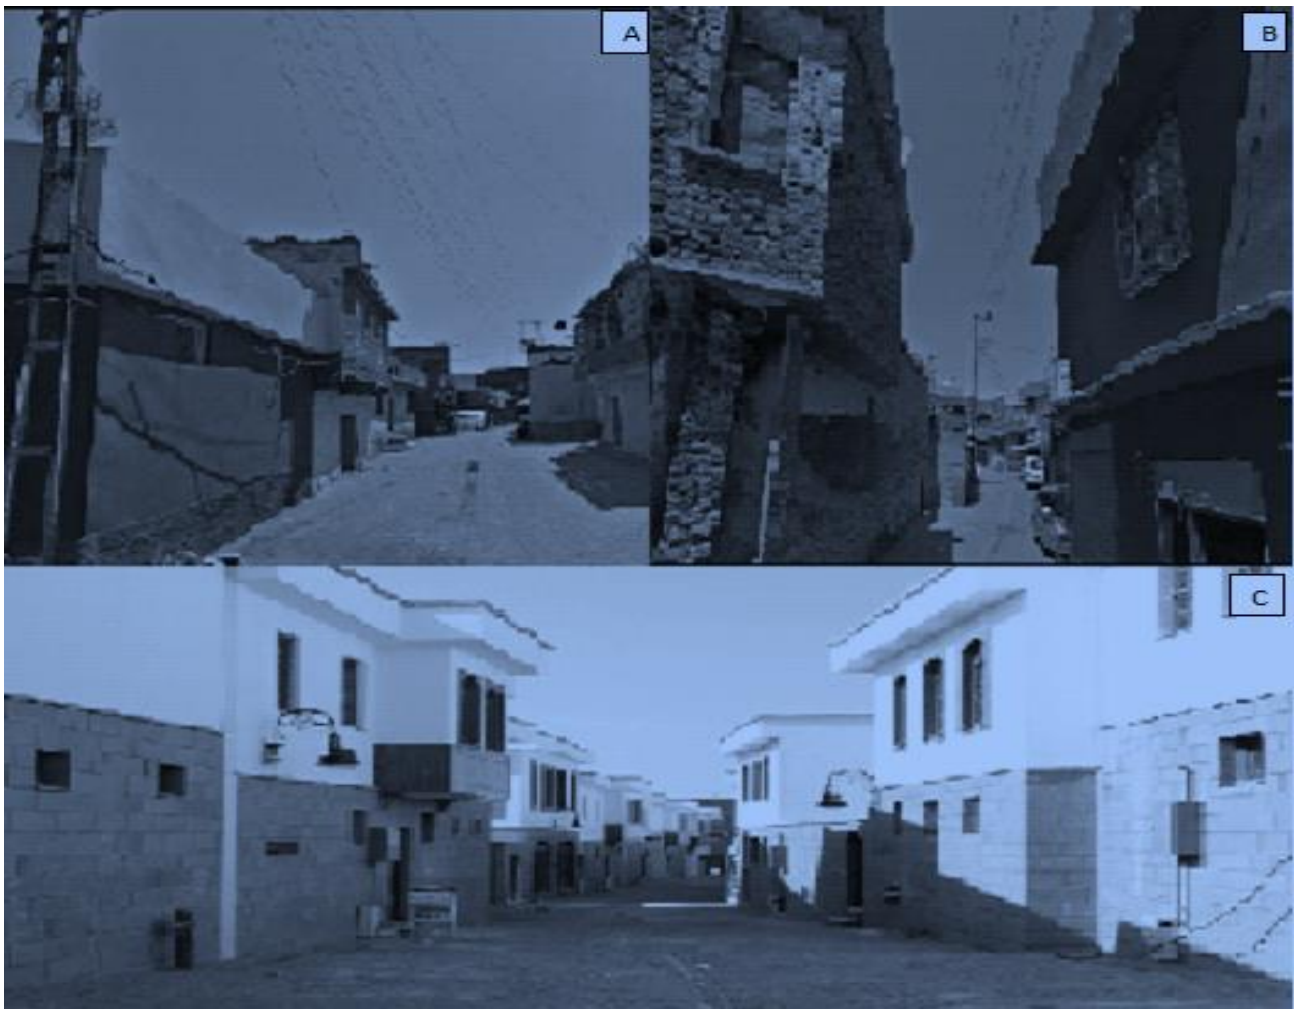
Since there was unplanned urbanization in the Suriçi region, there were narrow streets. These streets were an obstacle for municipal vehicles to enter the area. Thus, the garbage could not be collected sufficiently. Especially as seen in Figure 4A, and Figure 4C before and during urban transformation, rubble, medical wastes, waste batteries, construction material wastes were discarded randomly. Since there was unplanned urbanization in the Suriçi region, there were narrow streets. These streets were an obstacle for municipal vehicles to enter the area. Thus, the garbage could not be collected sufficiently. Especially as seen in Figure 4A, and Figure 4C before and during urban transformation, rubble, medical wastes, waste batteries, construction material wastes were discarded randomly. These were not creating an aesthetically pleasing image. After the completion of the urban transformation, as seen in Figure 4B, with the widening of the roads, the garbage was collected more easily and the ugly excavation and waste images in the environment could be removed. Urban transformation has had a positive effect both in terms of health and aesthetics appearance.

Figure 4. Before urban transformation and after urban transformation Suriçi (2018) [14]

In urban transformation, protection of water quality is essential, to prevent water pollution and safely transmit clean drinking water from its source to the user. As seen in Figure 4A, during the 2015 terrorist incidents in the Sur region, the drinking water pipes in the city were damaged as a result of the ditch digging incidents in the region and the water in the city. Damaged water pipes brought many negativities. The waters were heavily polluted and many diseases (typhoid, nausea, etc.) have emerged. As can be seen in Figure 5, 25.686 meters of drinking water line has been laid in the region with the urban renewal works and the drinking water problem has been solved.

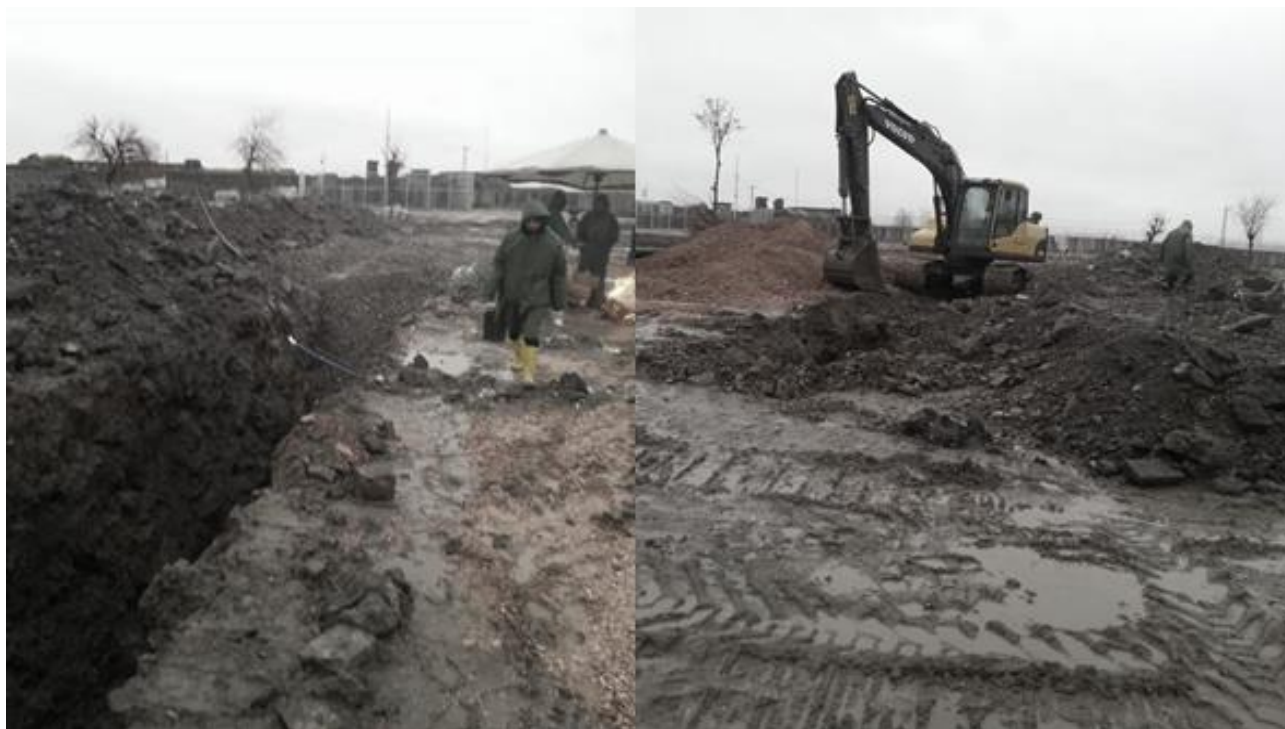
Figure 5. Images from the drinking water line laying Suriçi after urban transformation (2018) [14]

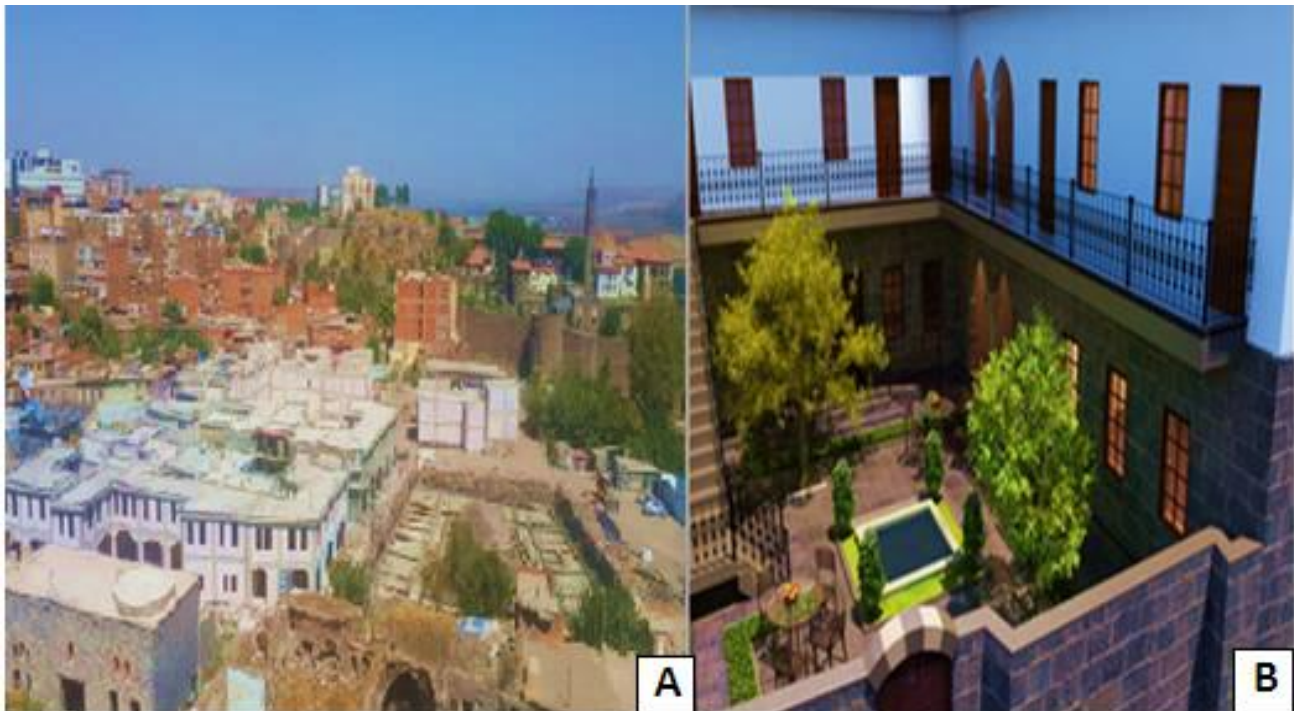
Figure 7. A view of the newly built houses before and after the urban transformation (2018) [14]

As seen in Figure 7. A, there was a historical texture in old traditional houses. But the structures had a complex and overlapping appearance. There was almost no green space around traditional houses. As can be seen in Figure 7. B, although the new buildings do not exactly reflect the old historical texture, the renovation works have brought a new breath to the city. People's quality of life has risen to higher levels. Traditional architectural structures predicted a healthier and more economical life in houses. Naturally the situation had reflected. However, newly made buildings are designed to take into account more current needs. In general, when the renewing evaluation, especially in terms of environment and health, the architectural structure of the houses is considered more favorable. The evaluated data showed that in terms of architecture and history is a negative effect; in terms of general supplies and current need, reception is positive effects.

Numerous buildings in Sur district were damaged. Damaged buildings were renovated with urban transformation. Care has been taken not to lose the historical and cultural texture of the buildings reconstructed here. However, the originality of the historical missions and architectural forms of these structures has also been lost. The houses built covered an area of 13.000 square meters. Reconstructed houses were kept small in square meters. The reason for this situation is, while crowded families lived in the past, there are small families now. Bathroom, kitchen, and living room on the ground floor of the two-story houses, bedrooms, and bathrooms are built on the first floor. Basement floors are planned to be used as warehouses.

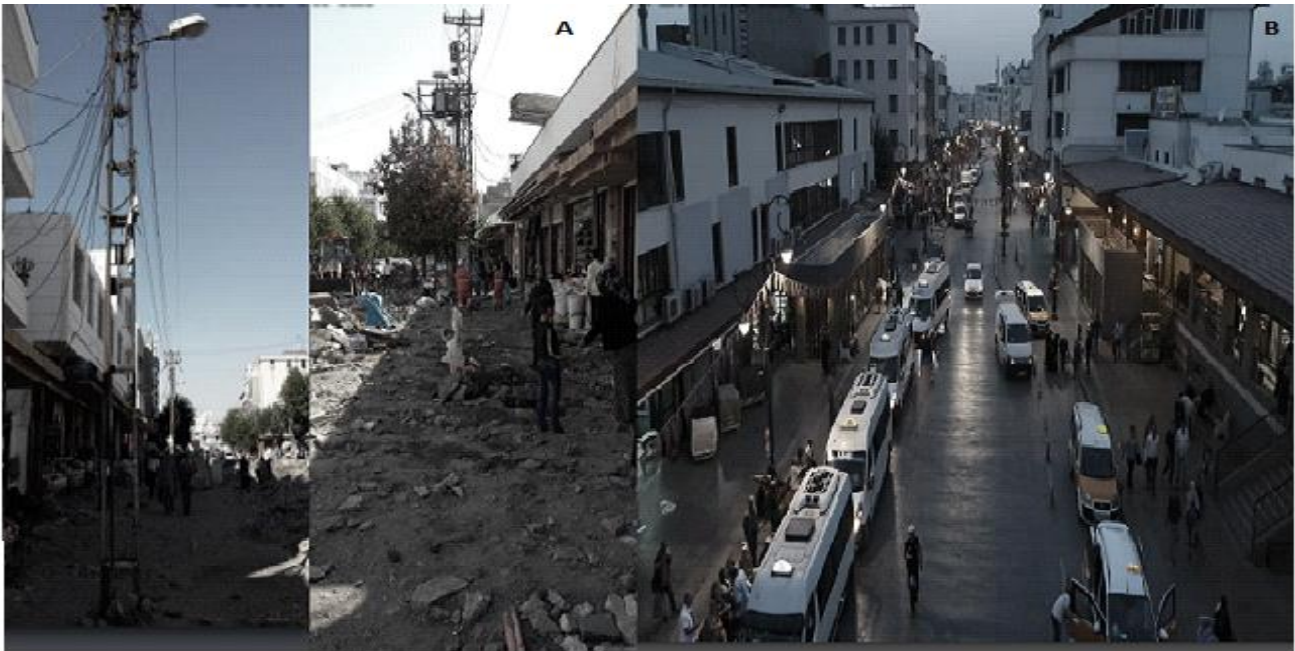
streets of their houses. Since the Sur region was the heart and busiest place of Diyarbakir, people met all their shopping needs from here. As can be seen in Figure 8. People could not walk comfortably because the streets were narrow and walking areas were difficult. After the urban transformation, as seen in Figure 8. B, the streets have been widened compared to the past and vehicle passages have become easier. It was concluded that urban transformation made a positive effect on traffic and transportation.

Figure 8. A view from Gazi Street in Sur District before and after urban transformation (2018) [14]

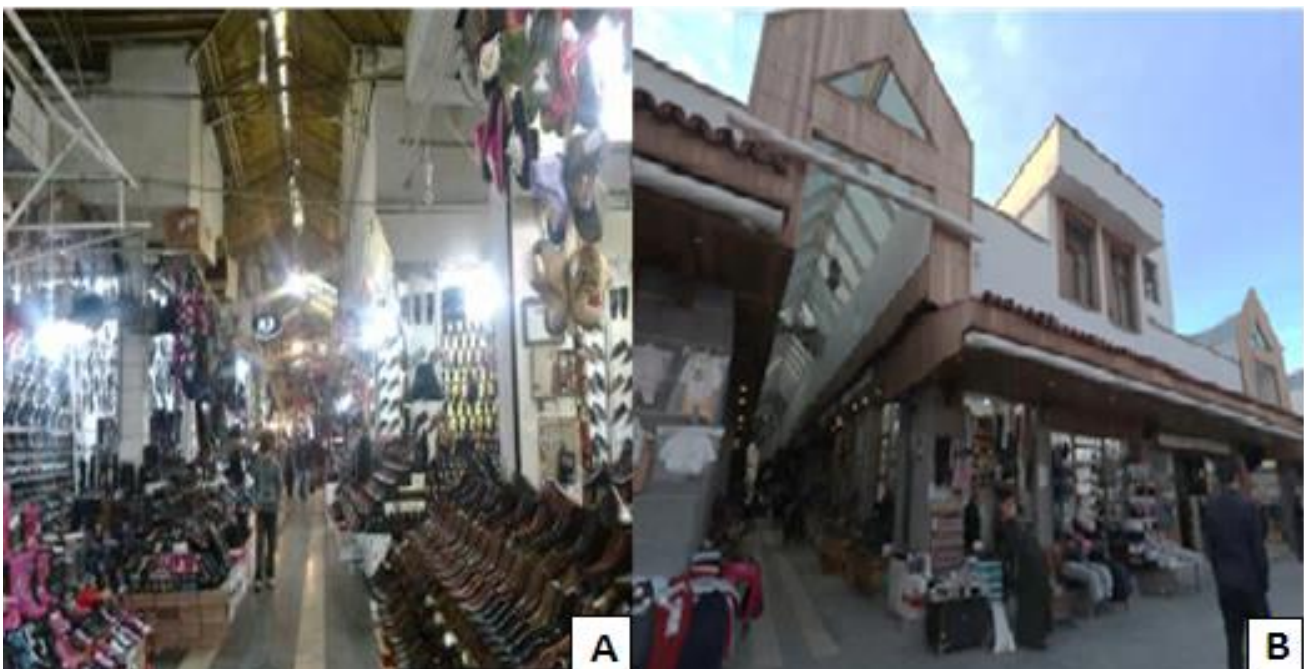
The garbage could not be collected regularly because of the narrow streets in the Sur region. There were old and dirty buildings images and unregular workplace signs. These caused the formation of undesirable odors and images in the environment. The sign and shape of the shops in the bazaar had spoiled the aesthetic image. As can be seen in Figure 9. The shop signs of the bazaar have become quite complex, and customers could not identify that they belong to any name. Along with the urban transformation, as seen in Figure 9. B, the signboards of the shops in the district were renewed with a wooden appearance.

Figure 9. A view from the burned bazaar facade cladding works before and after the urban transformation [14]

In this case, the signboards of the shops were changed with the urban renewal works, wooden signboards were made that appeal to the eye and make the shops attractive. At the same time, garbage collection problems have been removed. Old and dirty buildings were renovated. So, the urban transformation was determined to make positive effect on aesthetic pollution removing and image.
