Open centers for irregular migrants in Malta: A case of substandard habitable shelters

Keywords: Migrants, Open centers, Substandard accommodation, Malta

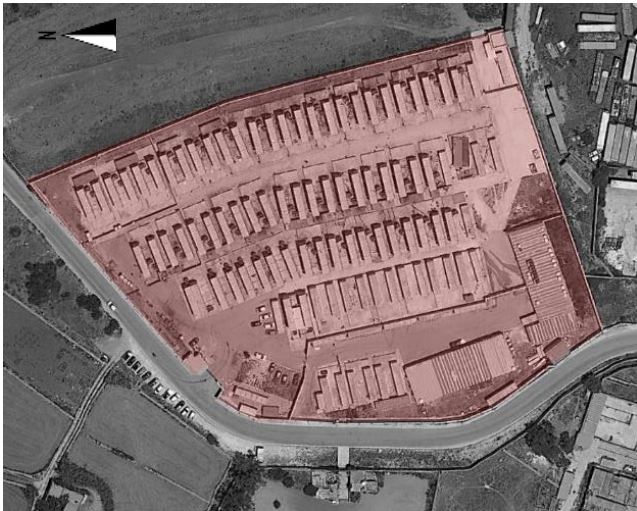
Figure 1. Satellite image of Hal Far Tent Village
(© Google Earth)

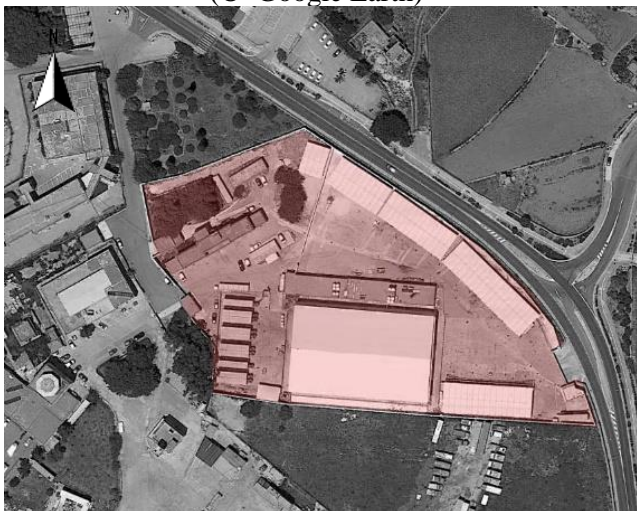
Figure 3. Satellite image of Hal Far Hangar Open Center
(© Google Earth)

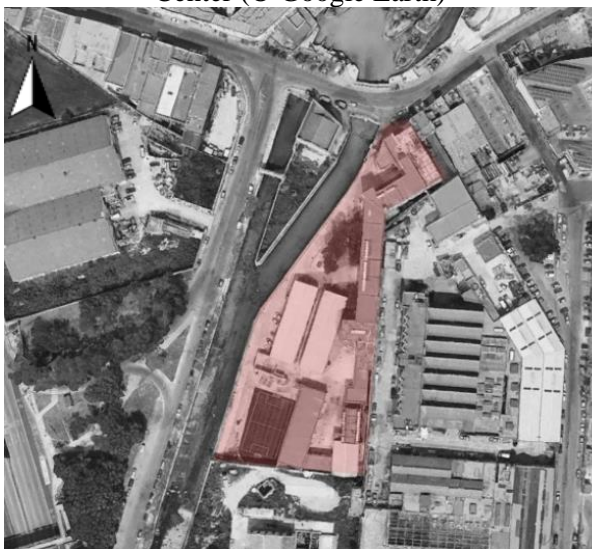
Figure 5. Satellite image of Marsa Open Center
(© Google Earth)

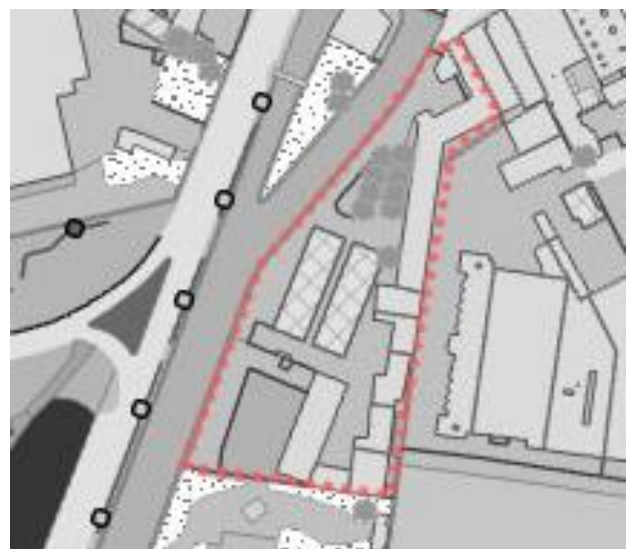
Figure 6. Layout of Marsa Open Center
(© PA Map Server, Malta)

Key features within the MOC site – AWAS's initial reception center for men and women – include a guards' room, a football ground, an administration block, the old trade school, offices, parking, dormitories, sanitation blocks, storage facilities, family quarters, a doctor's clinic, a family room, a kitchen and a laundry room. Some migrant accounts portray the accommodation at MOC as overcrowded and state that the site lacks running water and power. "The CPT [European Committee for the Prevention of Torture and Inhuman or Degrading Treatment or Punishment] considers that the situation found at Marsa I[nitial] R[eception] C[enter] on Floors 1 (fl. 1) and 2 (fl. 2) shows an establishment in disarray, which has allowed a dangerous, and potentially fatal, environment for detained migrants and its staff to develop and is symptomatic of [...] institutional neglect" [19: 12]. MOC has an on-site clinic for basic medical care [18], but it is unclear what mental health services are offered. MOC provides its inhabitants with some educational and job opportunities.
