# Preserving a historic form on the model of the sixteenth-century Osman Cehaja Mosque in Tuzla

This study analyzes the possibilities of preserving the form and renovating the historic mosque with a wooden porch and minaret, based on the Osman Cehaja Mosque in Tuzla as an example. The research is based on direct observation of property over several decades and a comparison of formal qualities with other relevant structures of a similar type and period. Except for its foundation, no information is available on its past or potential interventions. It is only reasonable to assert that it was originally covered with a wood shake. It is assumed that its appearance has not changed since the early twentieth century, based on a common memory. The mosque was renovated four years ago. Analysis of the previous and current appearances showed that the complete renovation did not compromise its form. In this respect, it is feasible to renovate the mahalla mosque with a wooden porch and minaret while preserving its historical character. More challenging cases may necessitate more extensive investigation, planning, and experience.

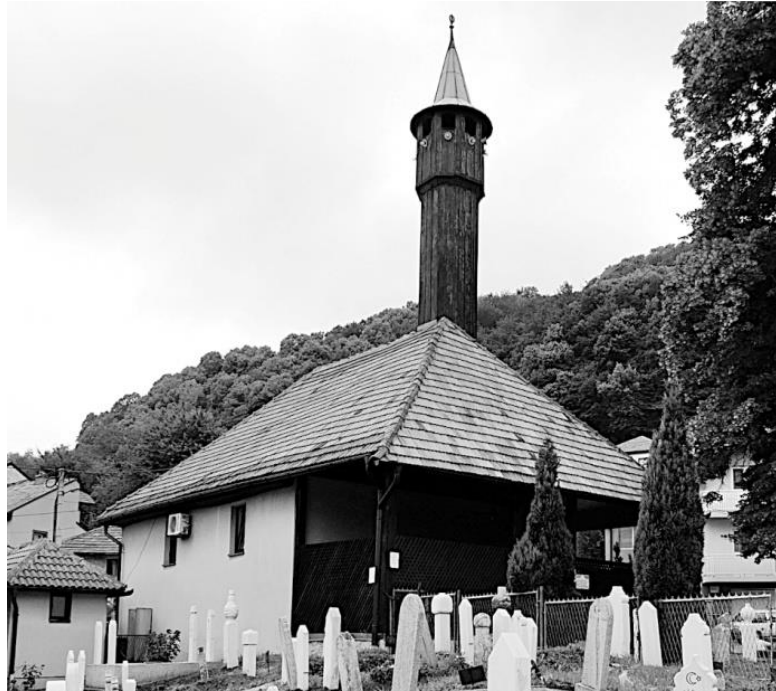
Figure 4. Osman Ćehaja Mosque in Tuzla before the renovation (Photo by the author)

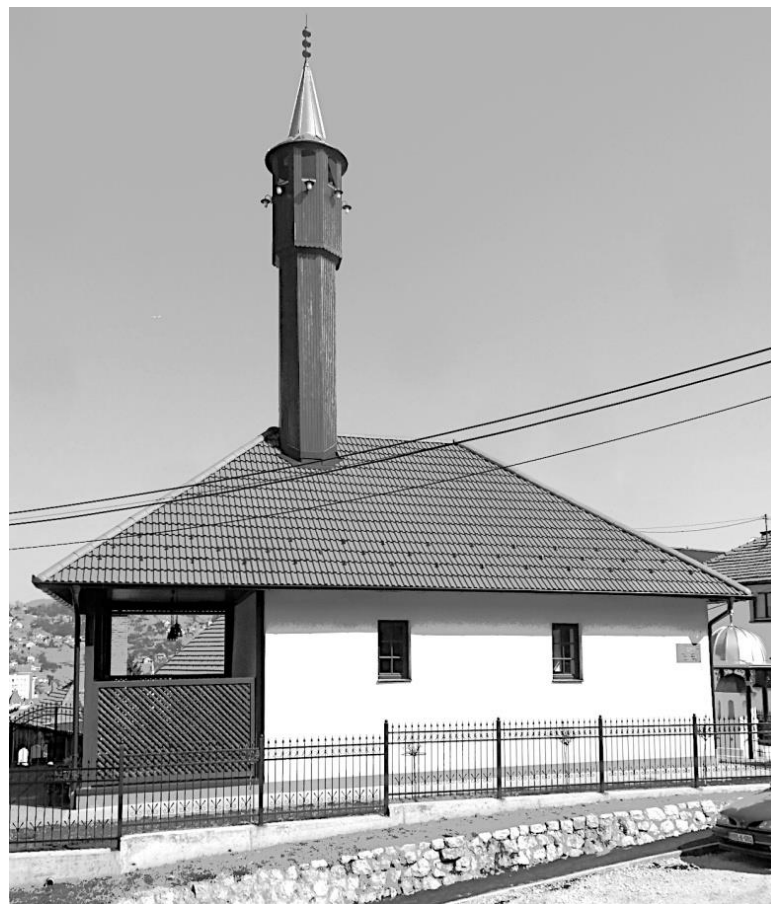
Figure 5. Osman Ćehaja Mosque after the renovation (Photo by the author)

In 2016, the Islamic Community in Tuzla initiated activities to refurbish the Osman Ćehaja Mosque. The works were completed and the mosque was opened in 2018 (Figure 5). The roof structure, minaret, porch, and other wooden sections were all consistently replaced, except for the walls. They were newly rendered and whitewashed on either side. The decaying roof structure and the wooden porch have been fully renovated with new timber material. As before, the roof is covered with clay tiles. In the interior, a new mahfil and minber were built based on the existing appearance and dimensions (Figure 6). The old windows were replaced with new ones that were the same size and shape. A comparison of its condition before and after the recent renovation demonstrates that it hasn't changed considerably from its former state. The renovation work was completed to a suitable level. However, some details needed more attention. The quality and thickness of the porch pillars are now a source of contention. They should be made of high-quality oak or pine, with the same (bigger) thickness, as in the prior condition. Secondly, the arch above the porch gate does not exactly match the former

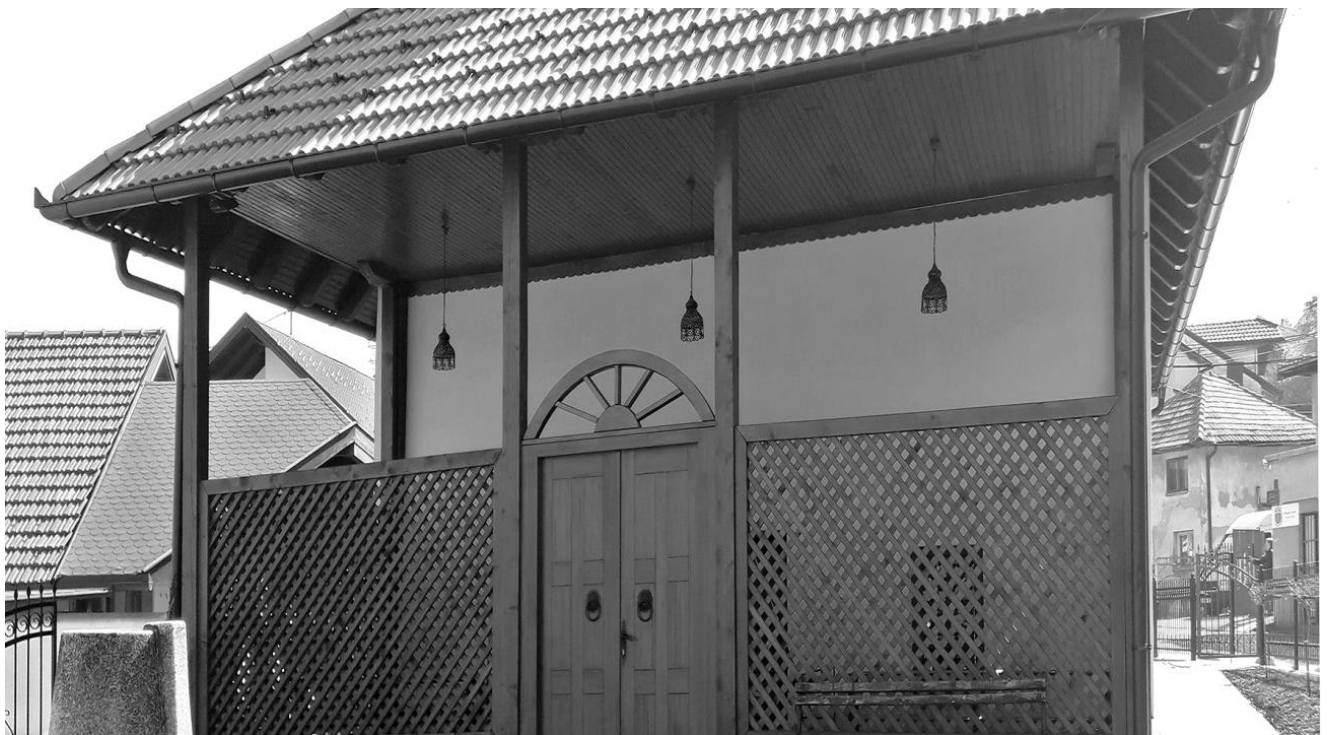
Figure 7. Front façade after the renovation (Photo by the author)

state's semicircular design (Figure 7). These are the fine details that the architect had to notice on time. Because this historic property is not officially protected by the state commission, there were no strict guidelines addressing all aspects of the renovation.
