Preserving a historic form on the model of the sixteenth-century Osman Cehaja Mosque in Tuzla

Keywords: Osman Cehaja Mosque, Mosque renovation, Tuzla mosques, Wooden minaret

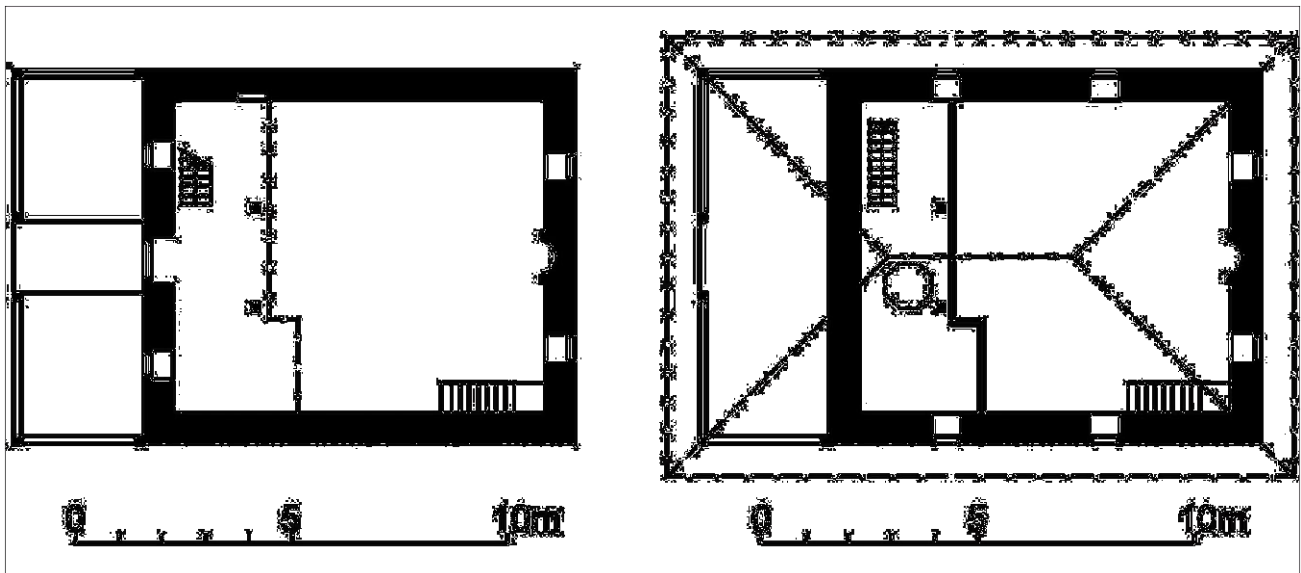
Figure 2. Floor Plans of Osman Ćehaja Mosque in Tuzla: Ground Floor (left), Mahfil (right) (drawings by the author)

The Osman Ćehaja Mosque is a typical Bosnian mahalla mosque with a wooden porch and minaret. In terms of common qualities, it shares typological values with numerous similar mosques in Bosnia and Herzegovina (Figure 2). Timber items, notably the roof cover, are likely to have been repaired and replaced regularly. The mosque is a single-unit structure with a slightly elongated rectangular prayer chamber and a wooden porch, both of which are crowned by a hipped roof covered with clay tiles. Probably when clay tiles became more widely available, the original decayed wooden cover (*šimla, tahta kiremit*) was replaced. A wooden minaret rises on the right side of the roof, typical of many mosques of this type. Unlike the typical arrangement of the lower and upper openings, which usually means sixteen windows, the peculiarity of this mosque lies in the unusual arrangement of the window openings. There are only ten rectangular windows, four in the *qibla* wall, two uppers on each side wall, and two lower windows on the entrance wall (Figure 4). A 1.8-meter-deep wooden mahfil is supported by side walls and two posts (*direk*) inside the mosque (Figure 3). The mihrab has a simple portal with a semicircular niche. A wooden carved minber typically stands in the right corner.

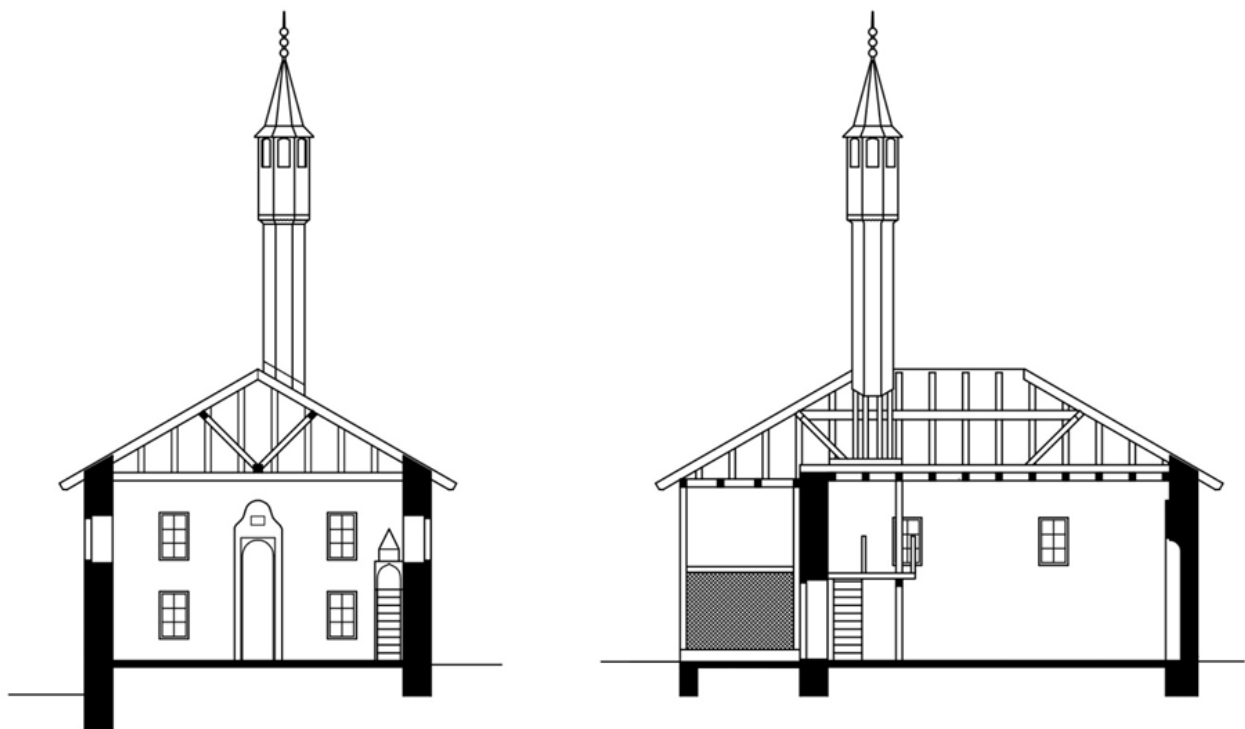
Figure 3. Cross sections of Osman Ćehaja Mosque: Transverse (left), Longitudinal (right), (drawings by the author)

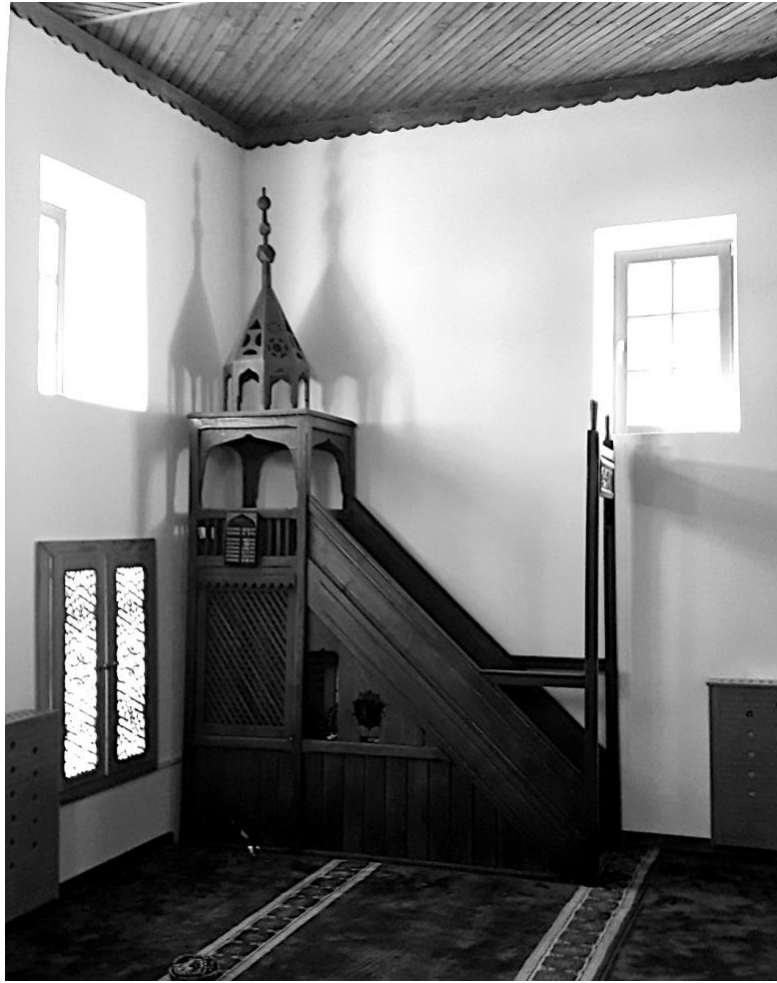
Figure 6. Interior of the mosque after the renovation showing minber (Photo by the author)

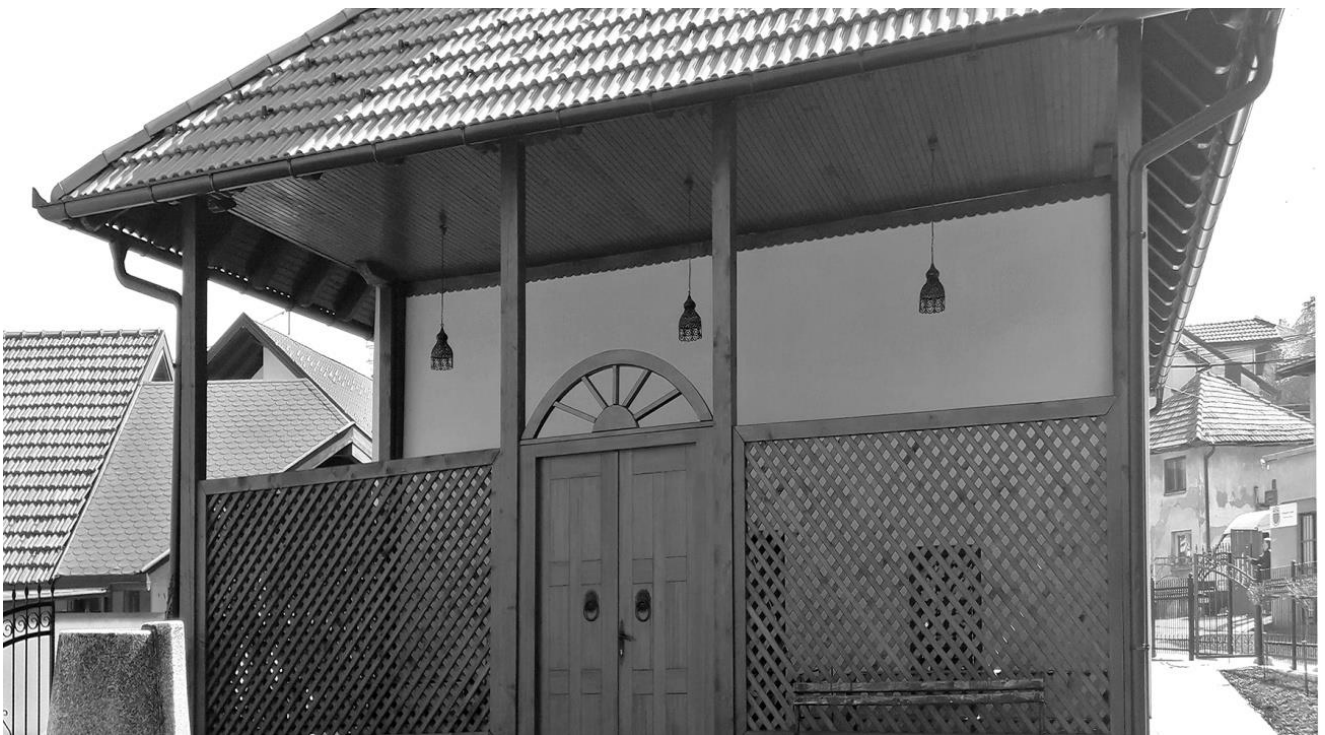
Figure 7. Front façade after the renovation (Photo by the author)

In 2016, the Islamic Community in Tuzla initiated activities to refurbish the Osman Ćehaja Mosque. The works were completed and the mosque was opened in 2018 (Figure 5). The roof structure, minaret, porch, and other wooden sections were all consistently replaced, except for the walls. They were newly rendered and whitewashed on either side. The decaying roof structure and the wooden porch have been fully renovated with new timber material. As before, the roof is covered with clay tiles. In the interior, a new mahfil and minber were built based on the existing appearance and dimensions (Figure 6). The old windows were replaced with new ones that were the same size and shape. A comparison of its condition before and after the recent renovation demonstrates that it hasn't changed considerably from its former state. The renovation work was completed to a suitable level. However, some details needed more attention. The quality and thickness of the porch pillars are now a source of contention. They should be made of high-quality oak or pine, with the same (bigger) thickness, as in the prior condition. Secondly, the arch above the porch gate does not exactly match the former

state's semicircular design (Figure 7). These are the fine details that the architect had to notice on time. Because this historic property is not officially protected by the state commission, there were no strict guidelines addressing all aspects of the renovation.
