Extended galleries above the porch in two mosques: Qualitative analysis of mosques with wooden minaret in Bosnia and Herzegovina

Edin Jahić^{1*}

¹Architecture Department, International University of Sarajevo, Bosnia

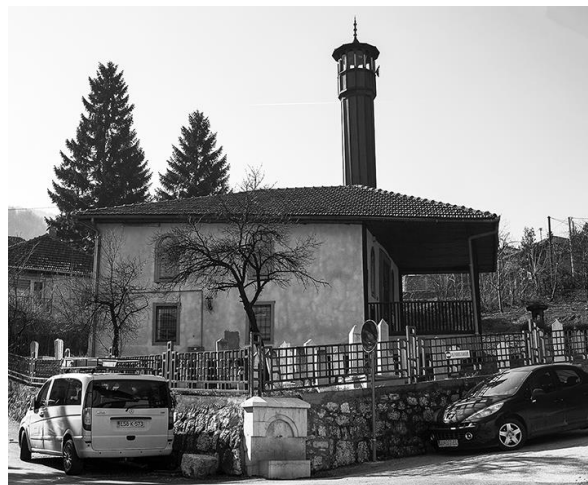
Figure 1. A typical mosque with wooden minaret and porch: Bali-beg Malkoč Mosque in Sarajevo. Photo by author

In comparison to a smaller number of monumental domed structures, the most of mosques are covered with pitched roof. According to architectural characteristics, pitched roof mosques are far more regionally differentiated [1]. The roof shape, pitch, and a roofing material, are closely related to a local tradition. Roofing with stone tiles prevails in Herzegovina; curved clay tiles (*čeremit*) are typical in Sarajevo region; while the use of wood shake (*šindra*) has been far more spread in the central and north Bosnia. While roofs in the north, as well as in higher areas of Bosnia, can be recognized by steep slope and deep eaves, by moving to the south, they tend to be lower, both with shorter, or even with no eaves at all. The roof is typically a hip, but rarely a pyramidal form. The unique hip form that covers both prayer space and adjoined porch prevails (Fig. 1).

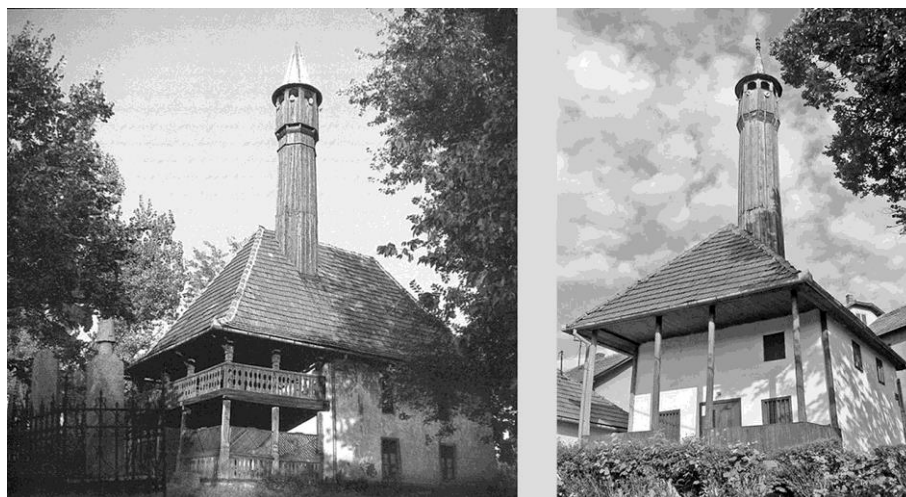
Figure 6. The Džindijska and Mejdanska Mosque before last renovations (before 1982); Photo by: anonymous photographer (left), author (right)

However, the image of the mosque taken before 1982 (Fig. 6), clearly shows changes made in the meantime. The building seemed deteriorated, with no extensions of the gallery above the porch, and with the roof

covered with clay tiles. Still, some details of decorative carving on the timber posts were visible. Thanks to the initiative of several conscious individuals in Tuzla, this valuable example of vernacular Bosnian architecture has been saved from the final disappearance.⁴ A few years later, the building was completely restored, except mud brick walls which were reinforced and newly rendered.⁵ In addition, the roof was renewed with original roofing material, wood shakes (*šindra*) (Fig. 8).

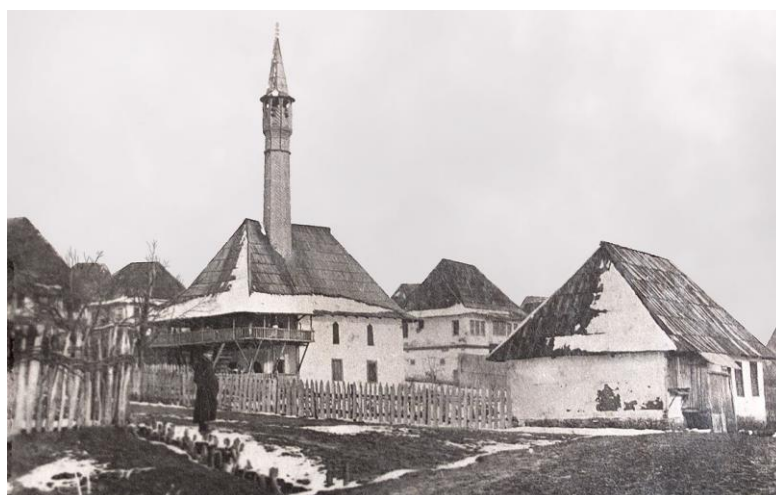
Figure 7. An old photo of the Džindijska Mosque with surrounding mahalle in the end of the 19th or the first decades of the 20th century; Photo by: anonymous photographer

The oldest known record of its appearance was made at the very end of the nineteenth century. In his brochure from 1899, “*The Folk House in Bosnia and Herzegovina*” [10], Rudolf Meringer brought aquarelle paintings with plans of several mahala mosques in Tuzla (Fig. 5) [9]. The image of the Džindijska Mosque shows extended gallery over the porch. Both gallery and roof eaves are supported by inclined bracing timbers (*čustek*). Another valuable source, probably of the later date, is an image shot by unknown photographer which shows the Džindijska Mosque including the nearest surrounding (Fig. 7).

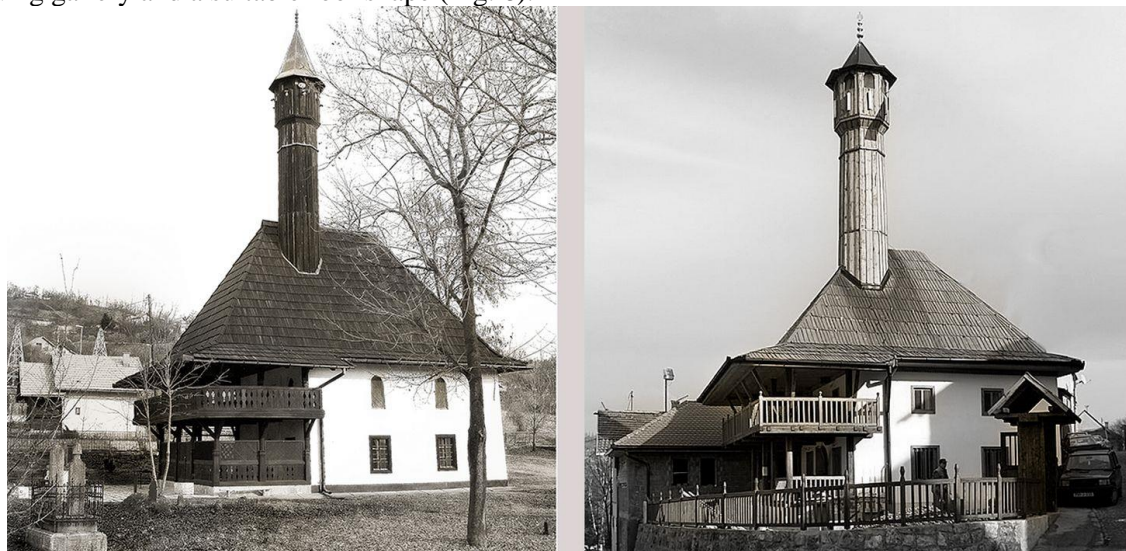
Figure 8. Two mosques after the renovation: The Džindijska Mosque (around 1982), and the Mejdanska Mosque (2005). Photo by: Mustafa Terzić (left); author (right)

supporting the exterior gallery and roof. The sofa is surrounded with low parapet made of wooden board (*parmak*). Prior to the last reconstruction in 2005, the appearance of the mosque was different from the current one. As many other mosques in Bosnia and Herzegovina, it had lost the original look during some of previous interventions, probably at the beginning of the twentieth century (Fig. 6). There was no gallery above the porch at all. During the last reconstruction, the mosque was restored to its previous appearance with a protruding gallery and a suitable roof shape (Fig. 8).
