Extended galleries above the porch in two mosques: Qualitative analysis of mosques with wooden minaret in Bosnia and Herzegovina

Abstract

Keywords: : Mahala mosque, Wooden minaret, Wooden porch, Extended gallery

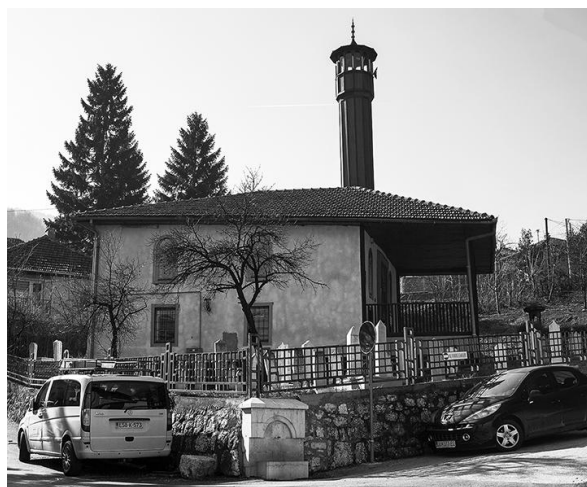
Figure 1. A typical mosque with wooden minaret and porch: Bali-beg Malkoč Mosque in Sarajevo. Photo by author

In comparison to a smaller number of monumental domed structures, the most of mosques are covered with pitched roof. According to architectural characteristics, pitched roof mosques are far more regionally differentiated [9]. The roof shape, pitch, and a roofing material, are closely related to a local tradition. Roofing with stone tiles prevails in Herzegovina; curved clay tiles (*čeremit*) are typical in Sarajevo region; while the use of wood shake (*šindra*) has been far more spread in the central and north Bosnia. While roofs in the north, as well as in higher areas of Bosnia, can be recognized by steep slope and deep eaves, by moving to the south, they tend to be lower, both with shorter, or even with no eaves at all. The roof is typically a hip, but rarely a pyramidal form. The unique hip form that covers both prayer space and adjoined porch prevails (Fig. 1).

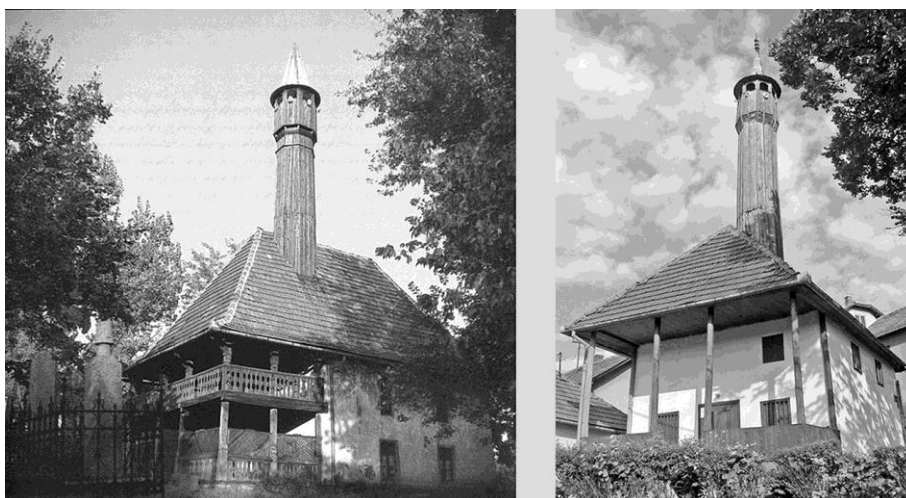
Figure 6. The Džindijska and Mejdanska Mosque before last renovations (before 1982); Photo by: anonymous photographer (left), author (right)

However, the image of the mosque taken before 1982 (Fig. 6), clearly shows changes made in the meantime. The building seemed deteriorated, with no extensions of the gallery above the porch, and with the roof covered with clay tiles. Still, some details of decorative carving on the timber posts were visible. Thanks to

(*parmak*). Prior to the last reconstruction in 2005, the appearance of the mosque was different from the current one. As many other mosques in Bosnia and Herzegovina, it had lost the original look during some of previous interventions, probably at the beginning of the twentieth century (Fig. 6). There was no gallery above the porch at all. During the last reconstruction, the mosque was restored to its previous appearance with a protruding gallery and a suitable roof shape (Fig. 8).

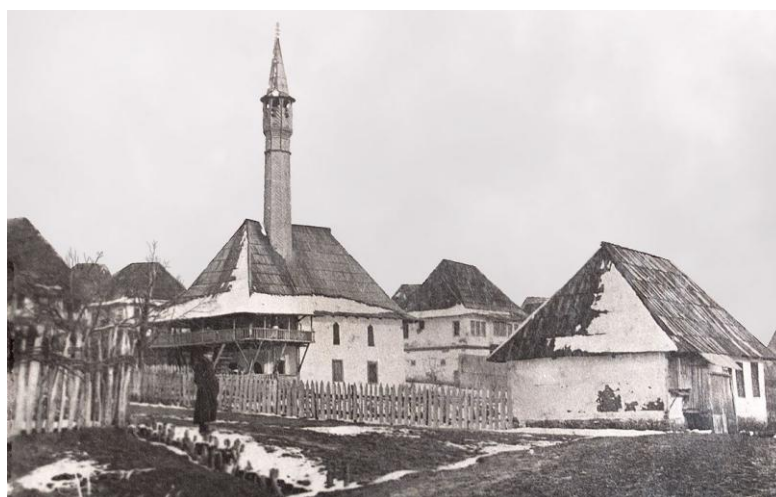
Figure 7. An old photo of the Džindijska Mosque with surrounding mahalle in the end of the 19th or the first decades of the 20th century; Photo by: anonymous photographer

The oldest known record of its appearance was made at the very end of the nineteenth century. In his brochure from 1899, “*The Folk House in Bosnia and Herzegovina*” [13], Rudolf Meringer brought aquarelle paintings with plans of several mahala mosques in Tuzla (Fig. 5). The image of the Džindijska Mosque shows extended gallery over the porch. Both gallery and roof eaves are supported by inclined bracing timbers (*ćustek*). Another valuable source, probably of the later date, is an image shot by unknown photographer which shows the Džindijska Mosque including the nearest surrounding (Fig. 7).

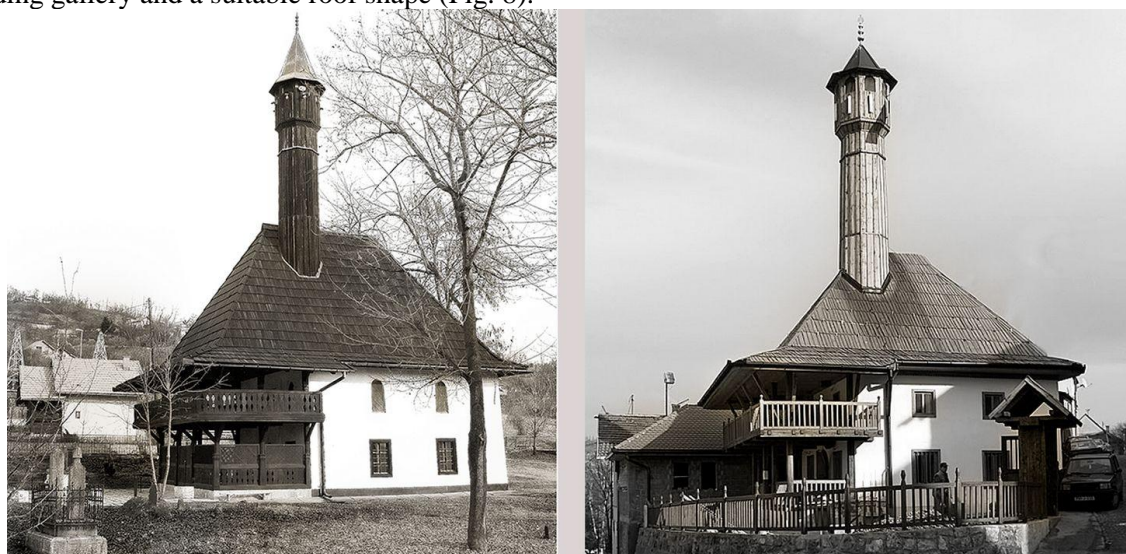
Figure 8. Two mosques after the renovation: The Džindijska Mosque (around 1982), and the Mejdanska Mosque (2005). Photo by: Mustafa Terzić (left); author (right)

the initiative of several conscious individuals in Tuzla, this valuable example of vernacular Bosnian architecture has been saved from the final disappearance.⁴ A few years later, the building was completely restored, except mud brick walls which were reinforced and newly rendered.⁵ In addition, the roof was renewed with original roofing material, wood shakes (*šindra*) (Fig. 8).
